SVHSER16000,  
REVISION: Basic  
DATA RIGHTS: N  
DATE: July 14, 1995

# SPACE STATION WATER PROCESSOR PROCESS PUMP

## Final Report

United Technologies Corporation

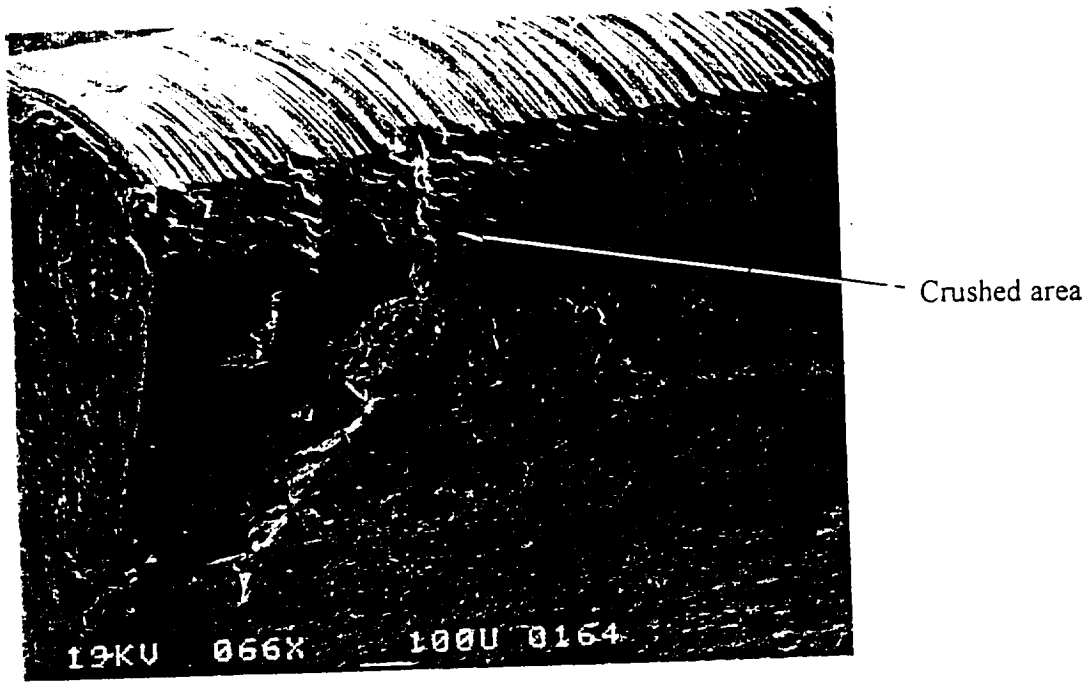
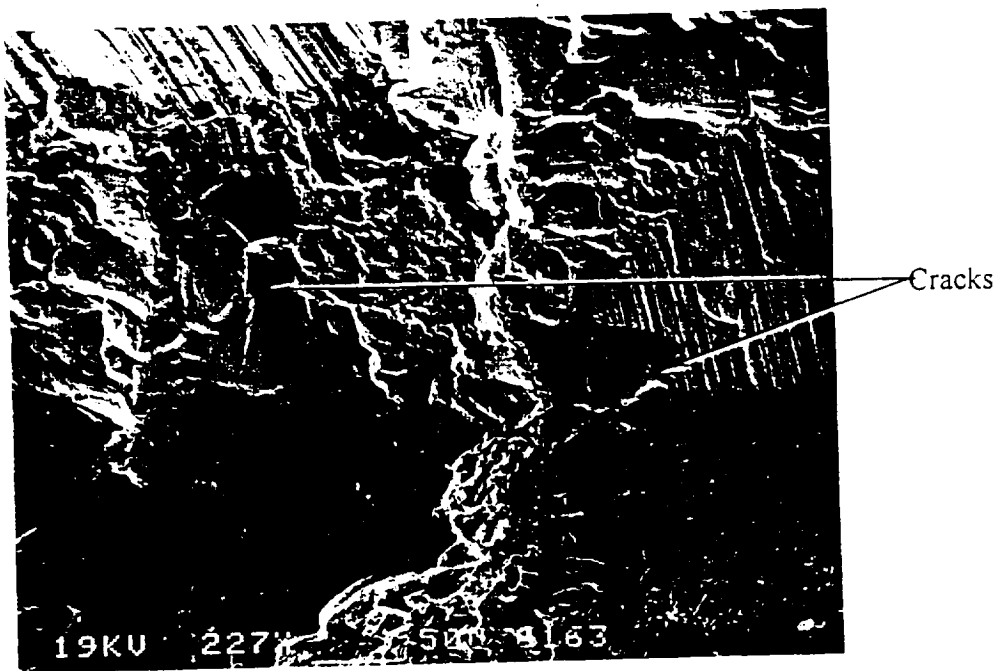
**Figure 7:** SEM photos at 66x and 227x of an area of the 718 drive gear that was crushed by a vice during sectioning. The cracking present is indicative of the brittle nature of the boride layer.

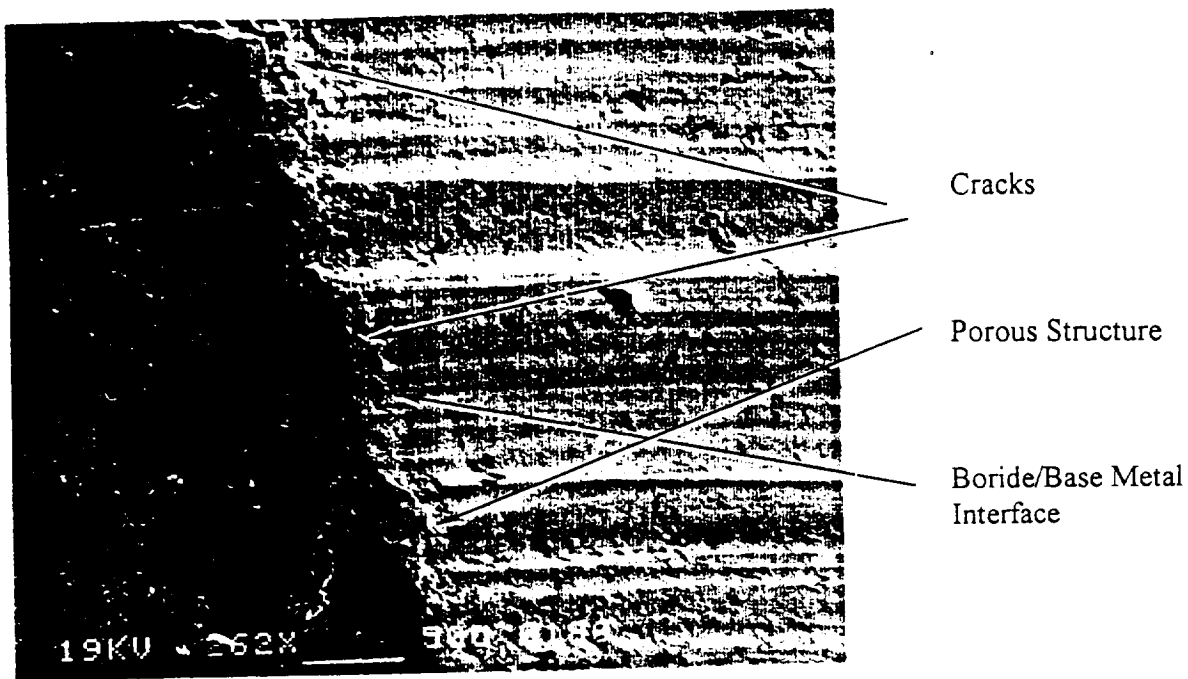
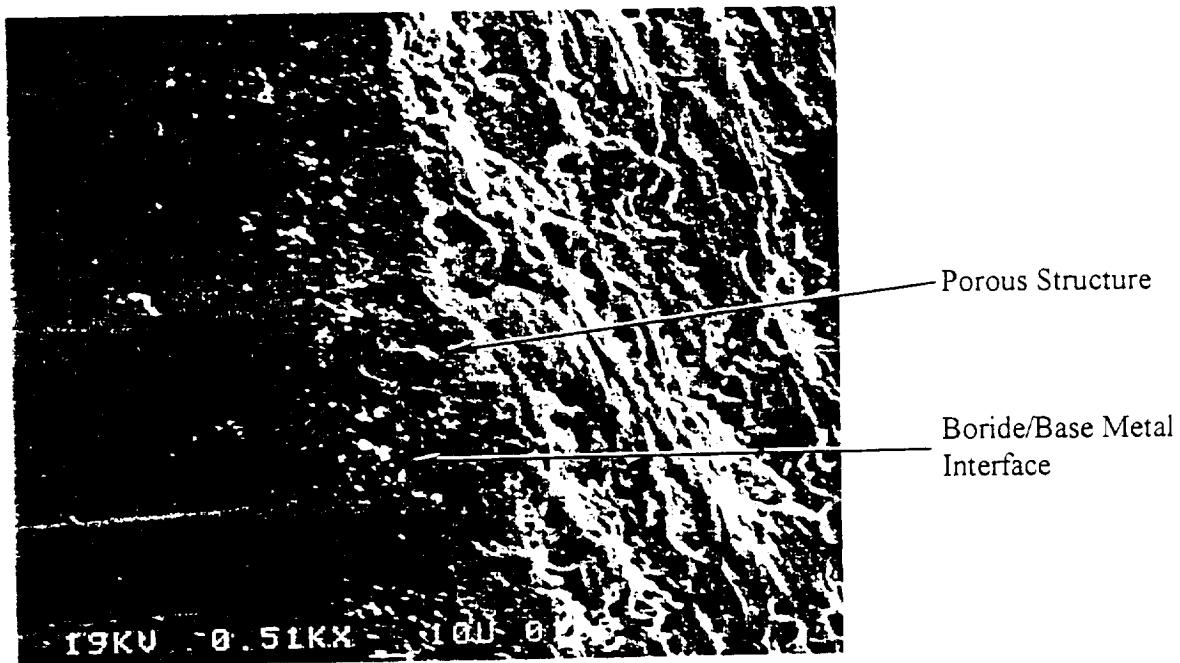
The examination of both the Inconel 718 and Stellite 6B gears in the areas near the edge of the removed boride showed cracks were present. These cracks likely indicate the coating was not sufficient to withstand the gear loading.

**Figure 12:** SEM photos of the boride layer adjacent to the worn areas on the 6B drive gear showing cracking, what appears to be a porous structure, and porosity/cracking at the boride/base metal interface.
